**THEORY AND PRACTICE OF
HERITAGE CONSERVATION AND RESTORATION
OF RASHTRAPATI NIWAS, SHIMLA**

CHHERING DORJE

INDIAN INSTITUTE OF ADVANCED STUDY
Rashtrapati Niwas, Shimla 171005

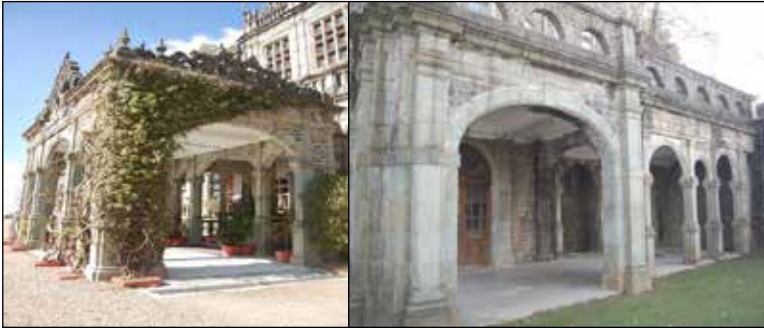
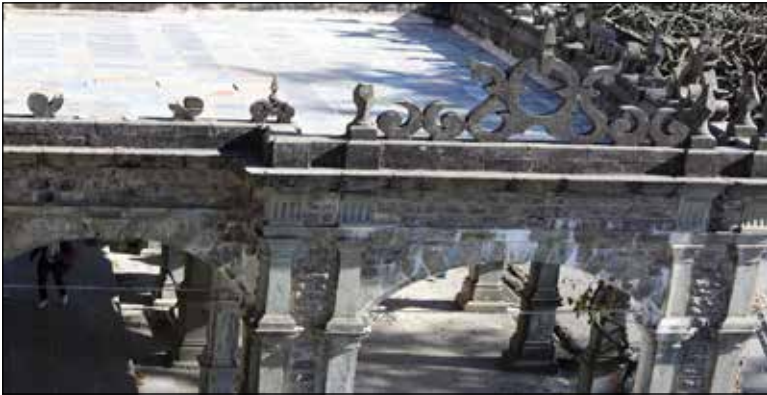
Leakage and water penetration from top roofs of the Entrance Portico

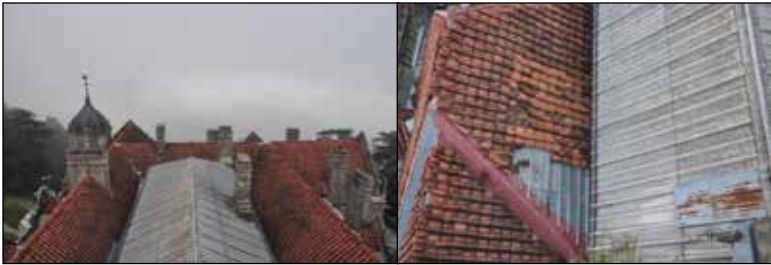
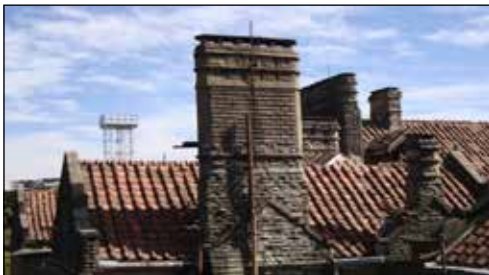
View showing present conditions of pitched roof.

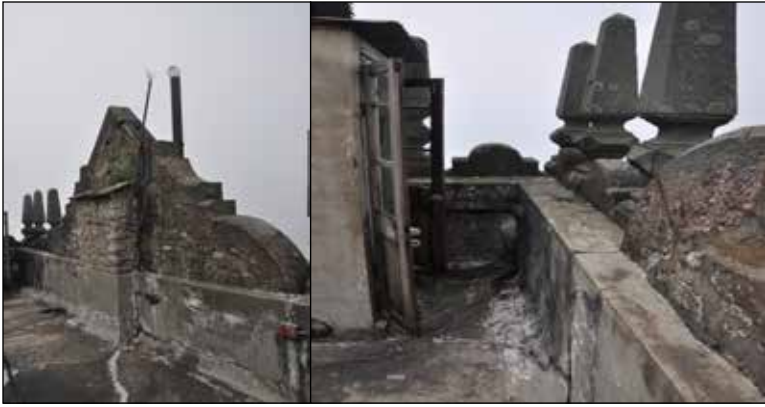
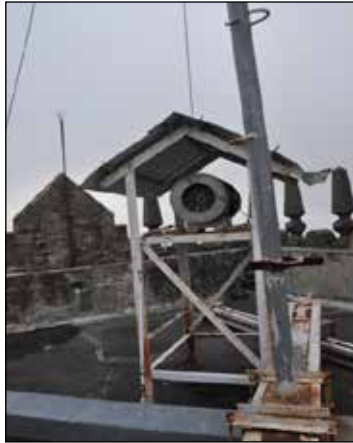
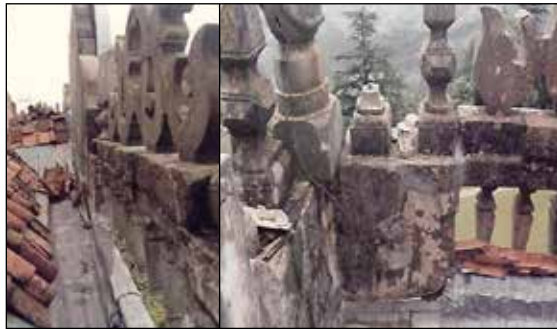
Central Tower:
Conditions of
interior junctions
between gable and
parapet walls

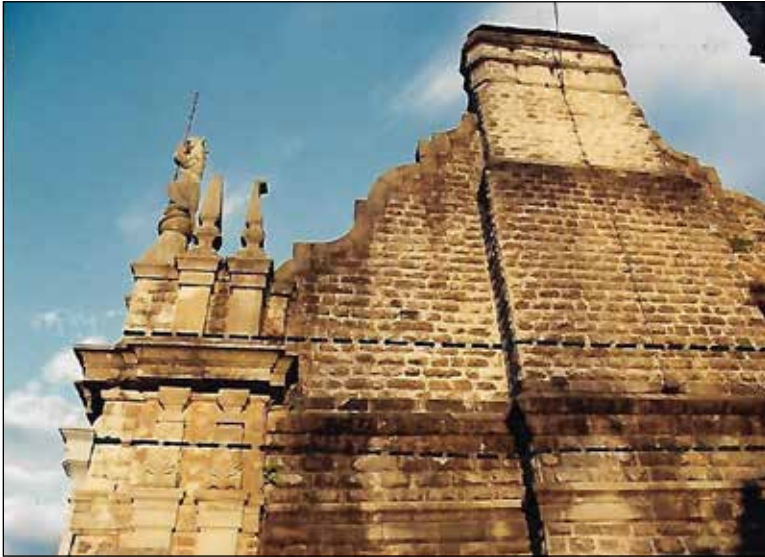
South-east corner of the Main building, showing vertical cracks in masonry joints

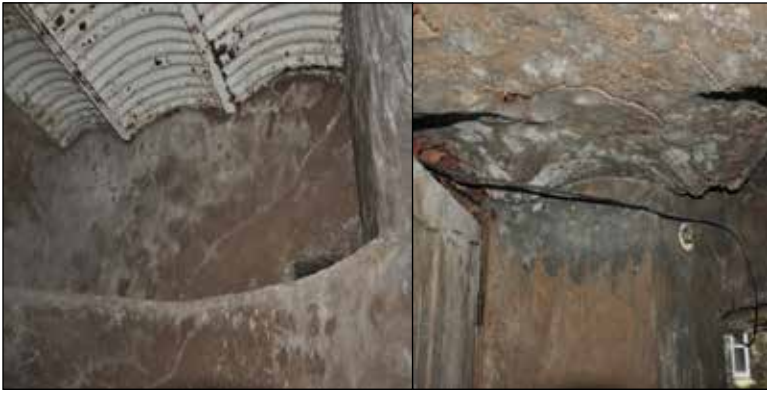
Jack arch roof deterioration due to corrosion, damp and seepage from top roof

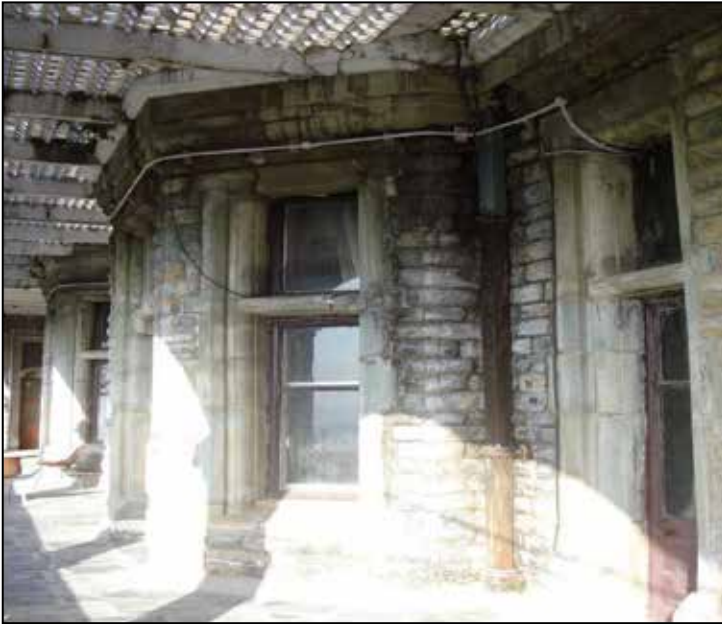
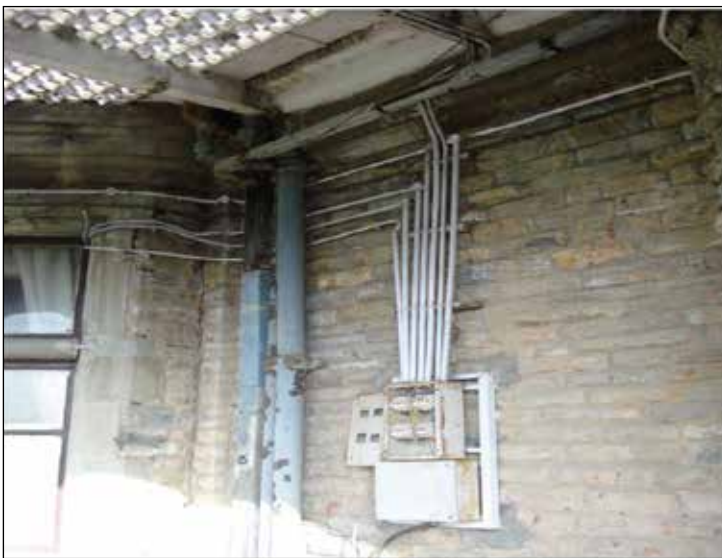
Structural damage of Oriel windows due to leakage and seepage from prism glass ceiling and new interventions

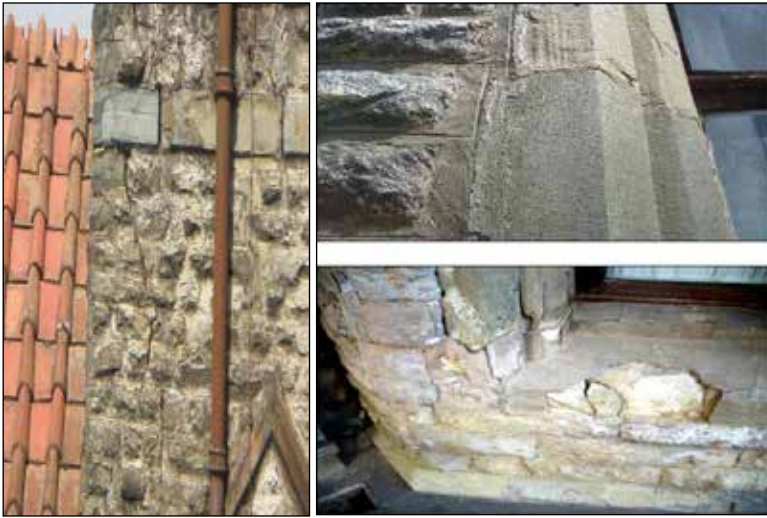
Cracks, blistering and flaking of architectural members due to weathering and seepage from top

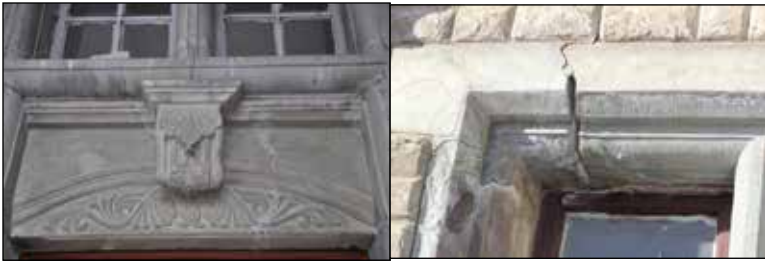
Masonry cracks at various locations of the main building

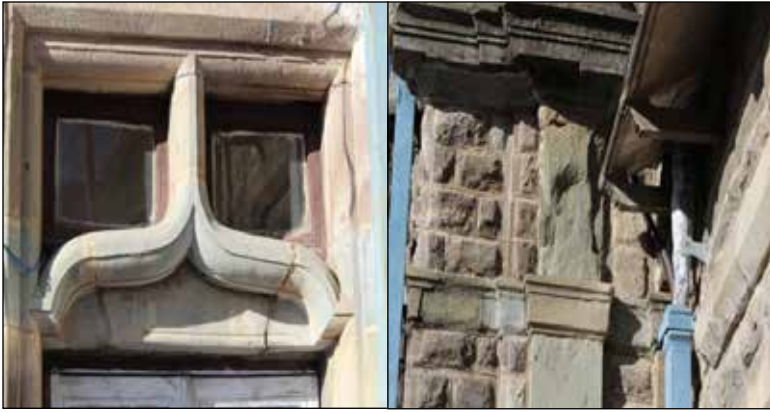
Development of cracks at different levels, Main Block

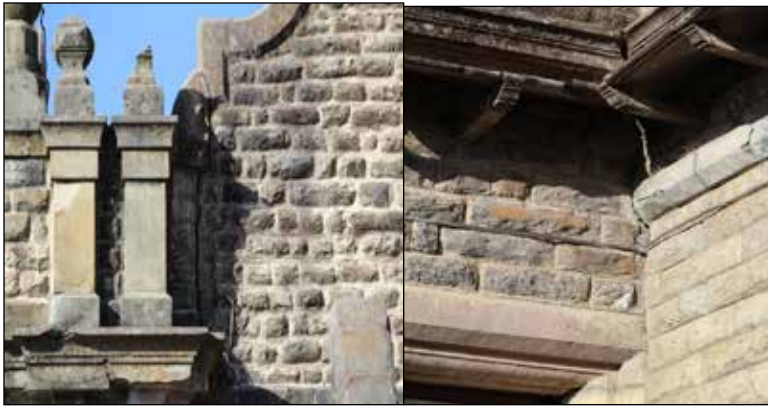
Main block showing masonry cracks at various locations

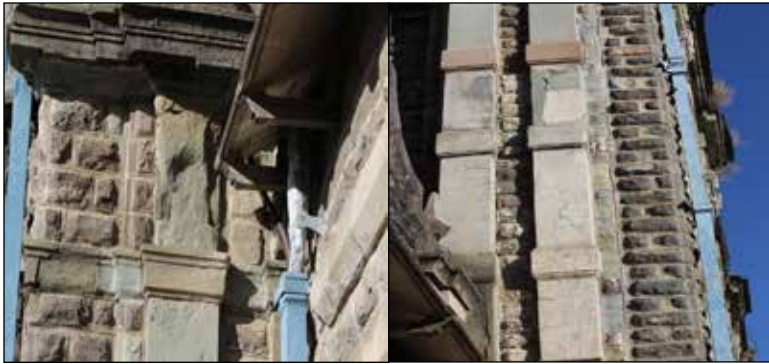
Main block showing masonry cracks at various locations

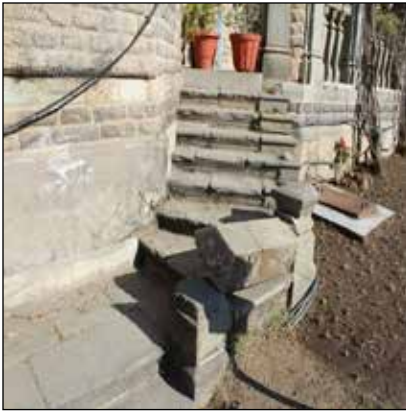
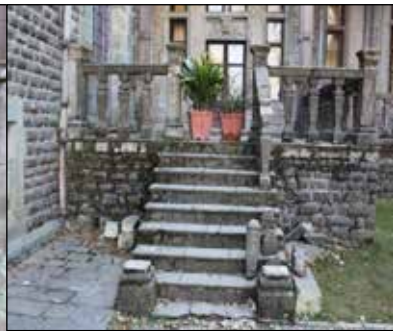
Present conditions of the stone masonry stairs

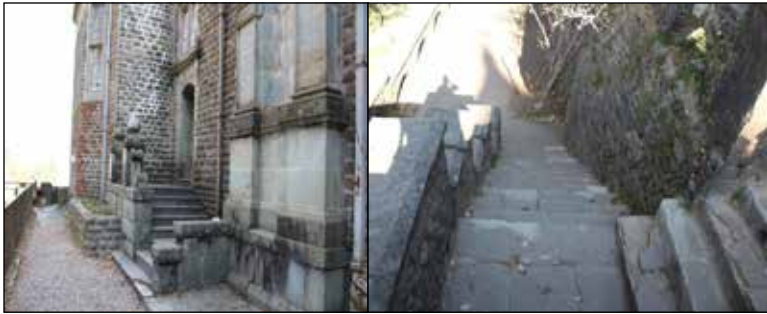
Conditions of the stone and cast iron spiral stairs at different locations

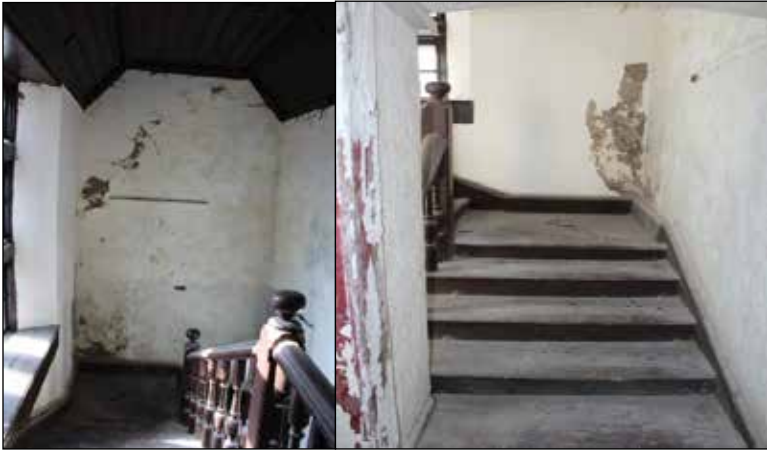
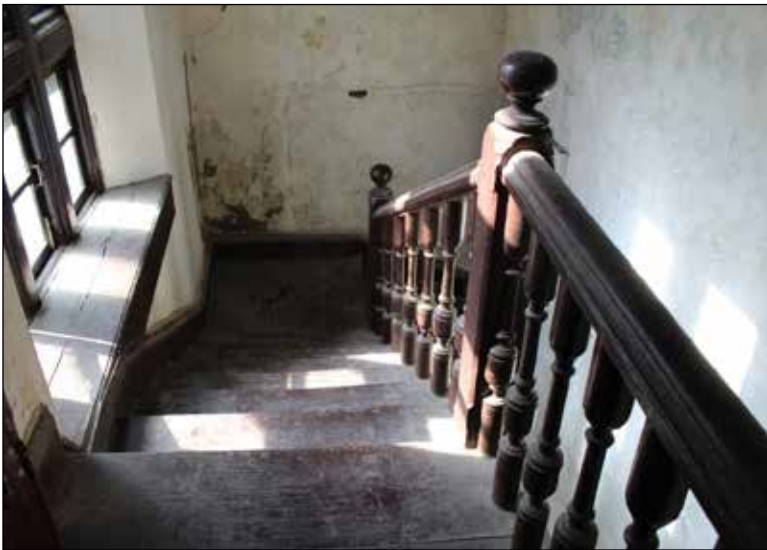
Condition of timber stairs

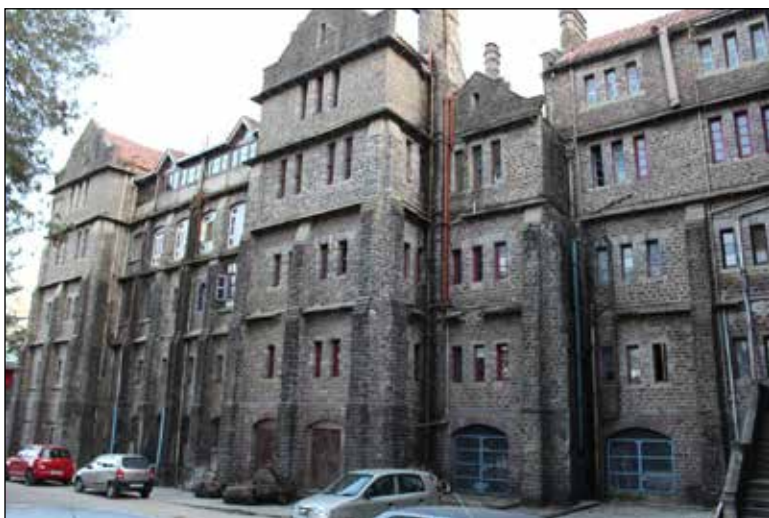
Exterior north view of the Kitchen Wing showing damaged downpipes and chhajas, etc.

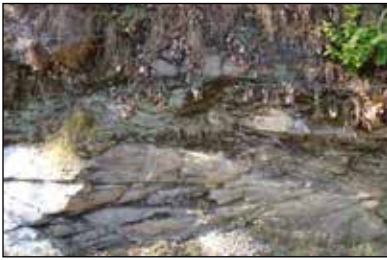
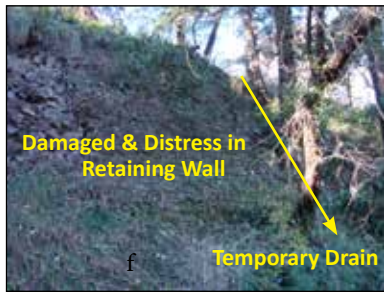
Damaged and distressed condition of rubble masonry retaining walls.
Source: IIAS.

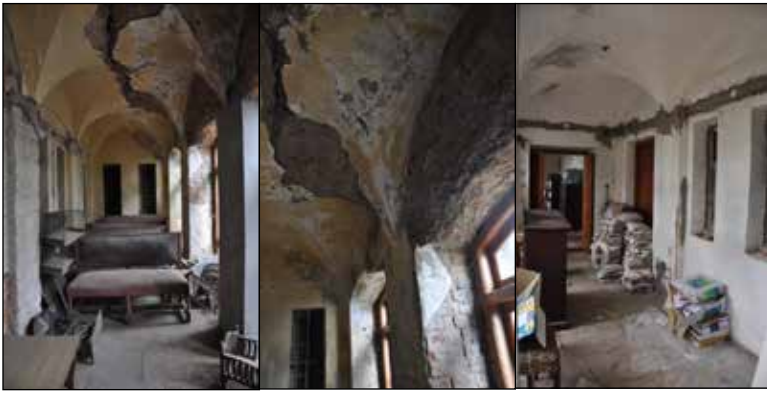
Deteriorated and distressed condition of the vaulted ceilings of corridors and rooms of Kitchen Wing

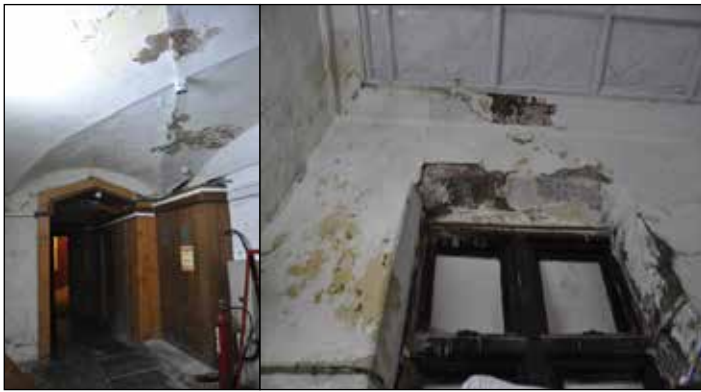
Ceiling and wall damages at various locations due to dampness and seepage from roof top

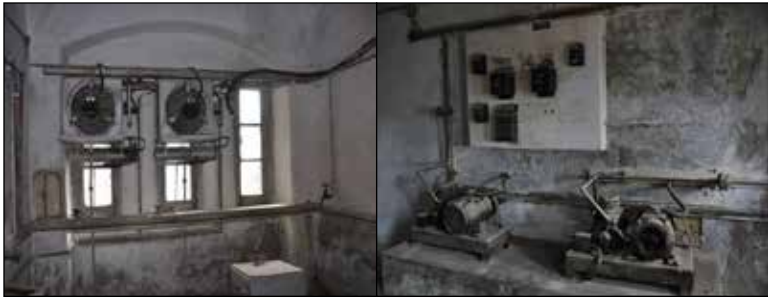
Kitchen Wing: deteriorated structural conditions of the rooms at laundry level

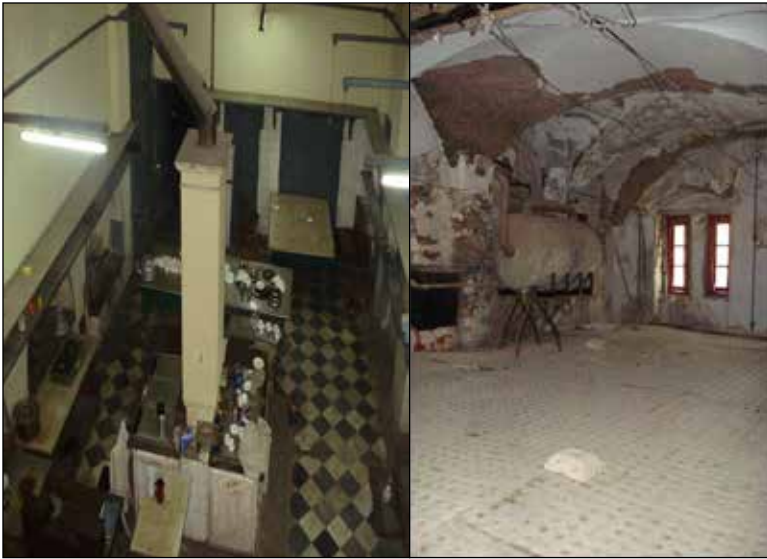
Kitchen Wing: Deteriorated vaulted chambers of the Kitchen due to cracks in the ceiling and damp.

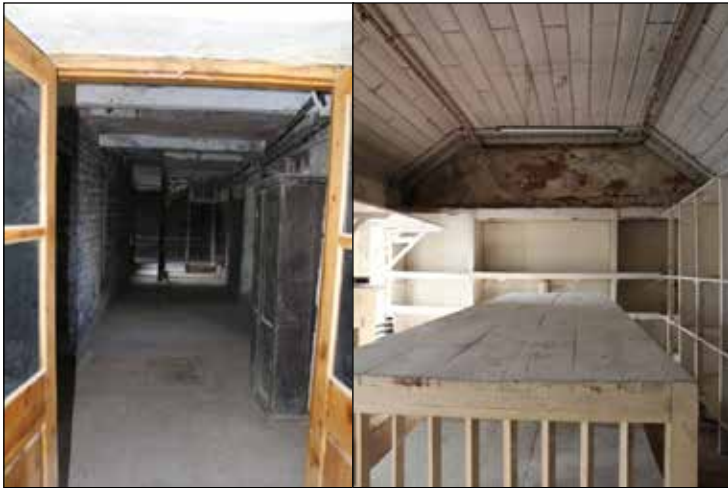
Deteriorated structural conditions of the top floor corridor and linen room of Kitchen Wing.

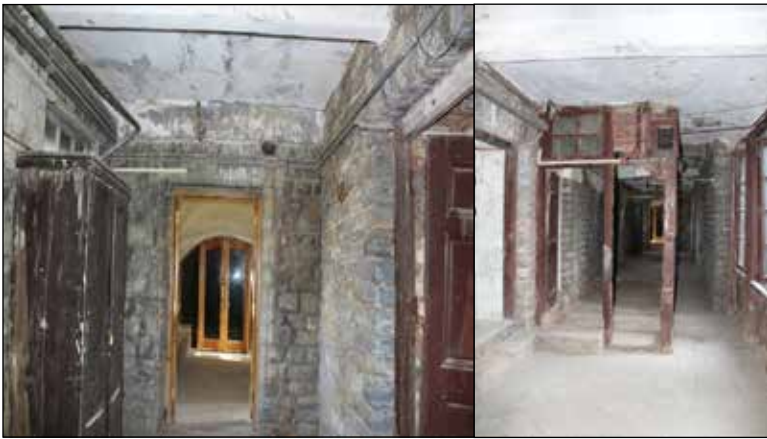
Kitchen Wing: deteriorated structural conditions of the top floor corridor and side rooms.

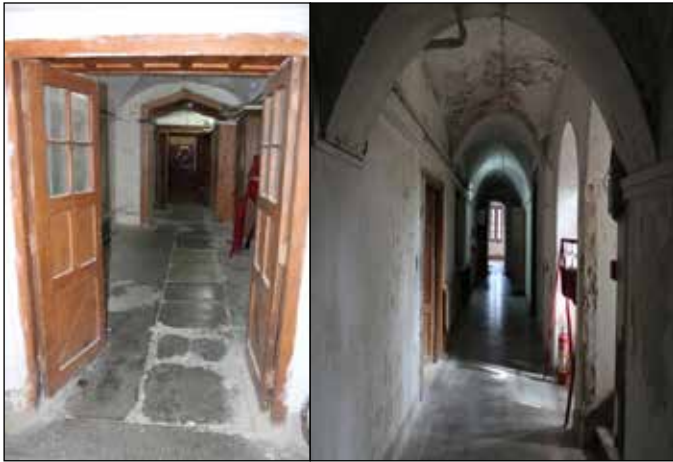
Kitchen Wing: deteriorated structural conditions of the top floor side rooms.

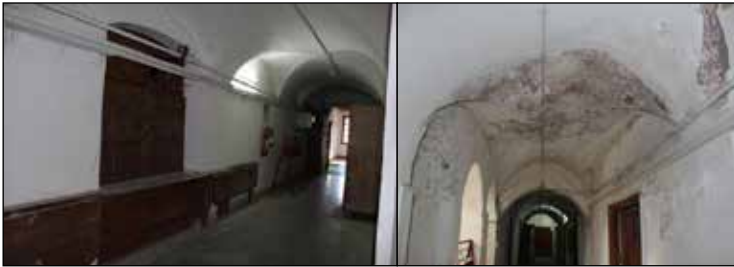
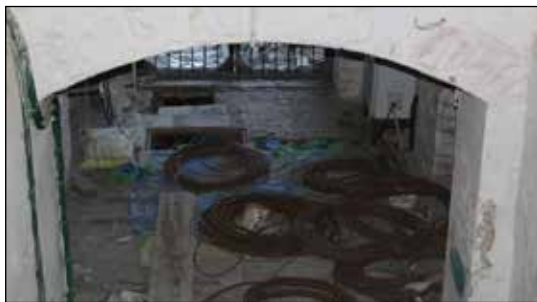
Kitchen Wing: deteriorated structural conditions of the corridor sub-basement and north main entrance.

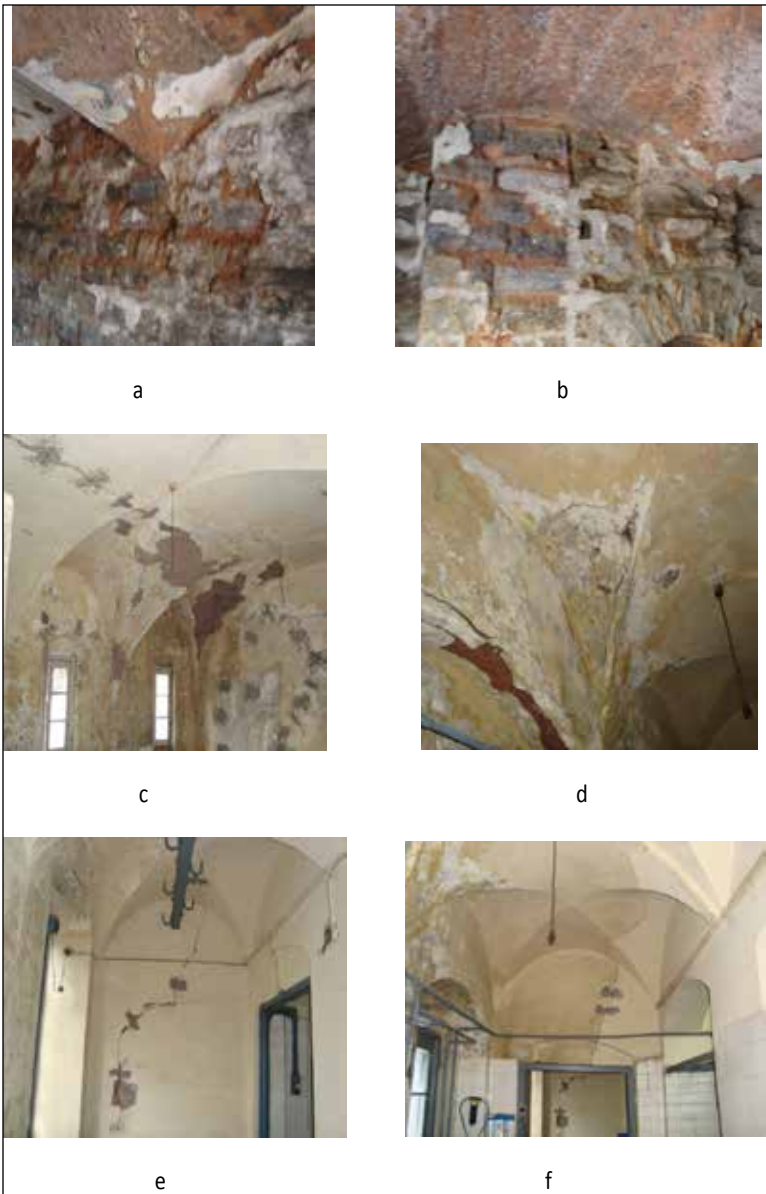
Kitchen Wing showing structural cracks in the vaulted ceilings due to dampness.

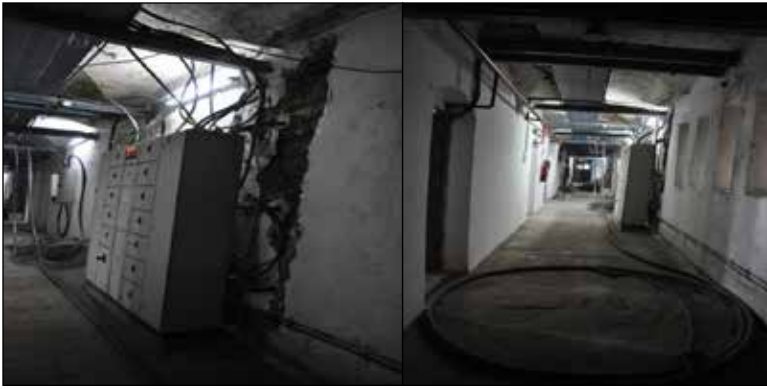
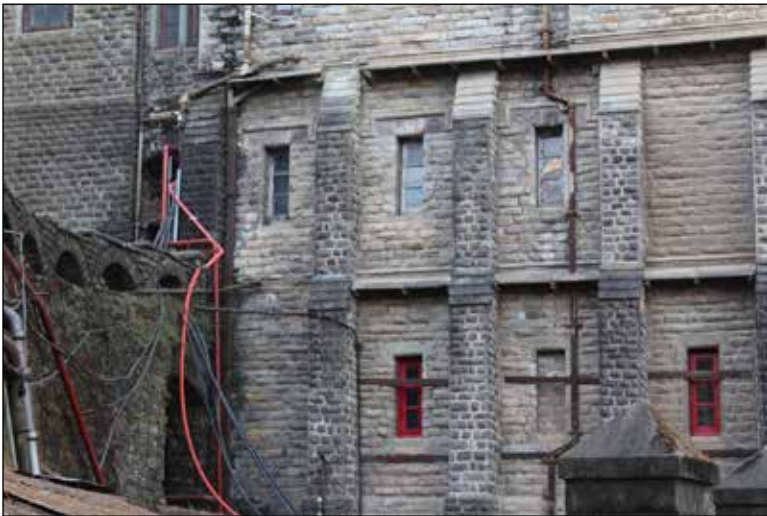
Structural damages due to new interventions on account of electric wirings.

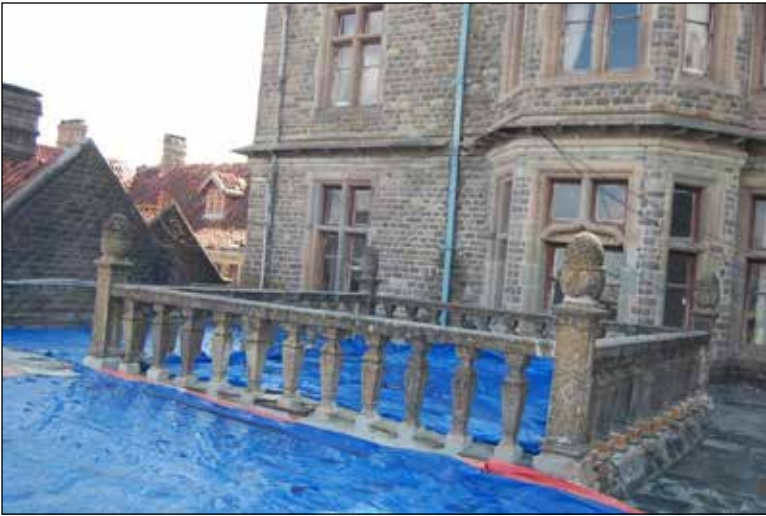
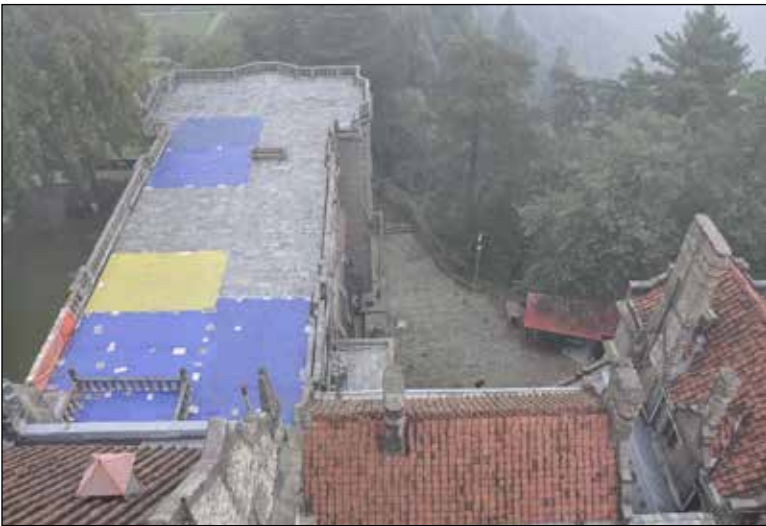
Water seepage from top flat roof of the Council Chamber due to failure of past measures

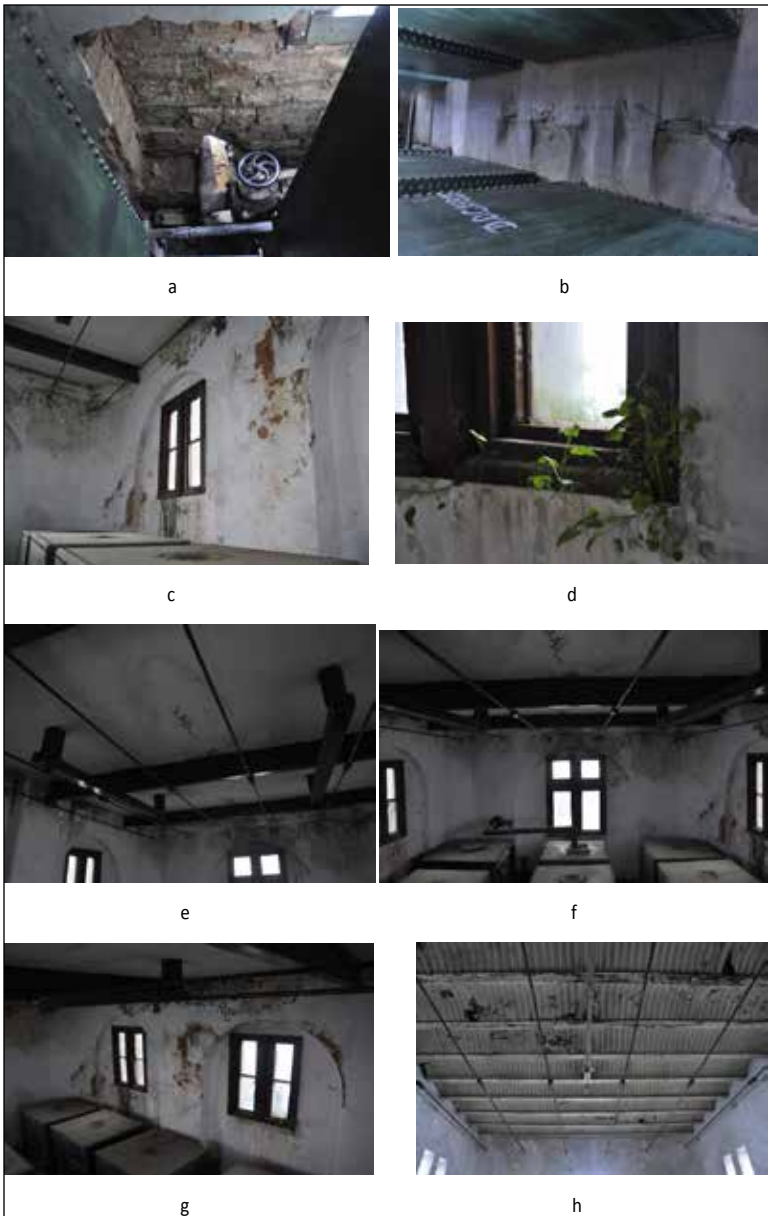
Interior distressed conditions of the Central Tower.

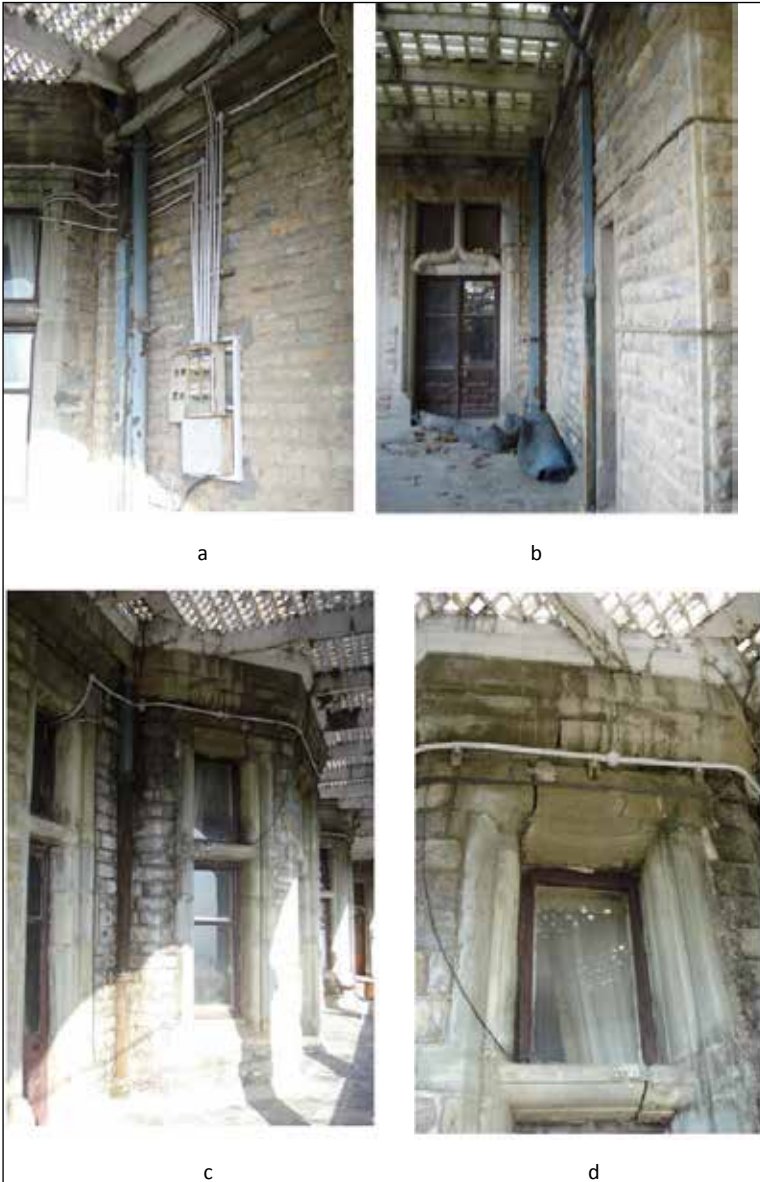
Structural damage due to water penetration from broken and missing Hayward Glass ceilings
