ROCKHEWN MONUMENTS OF KARKUNDA

KHWAJA MUHAMMAD AHMAD,

DIRECTOR OF ARCHÆOLOGY,

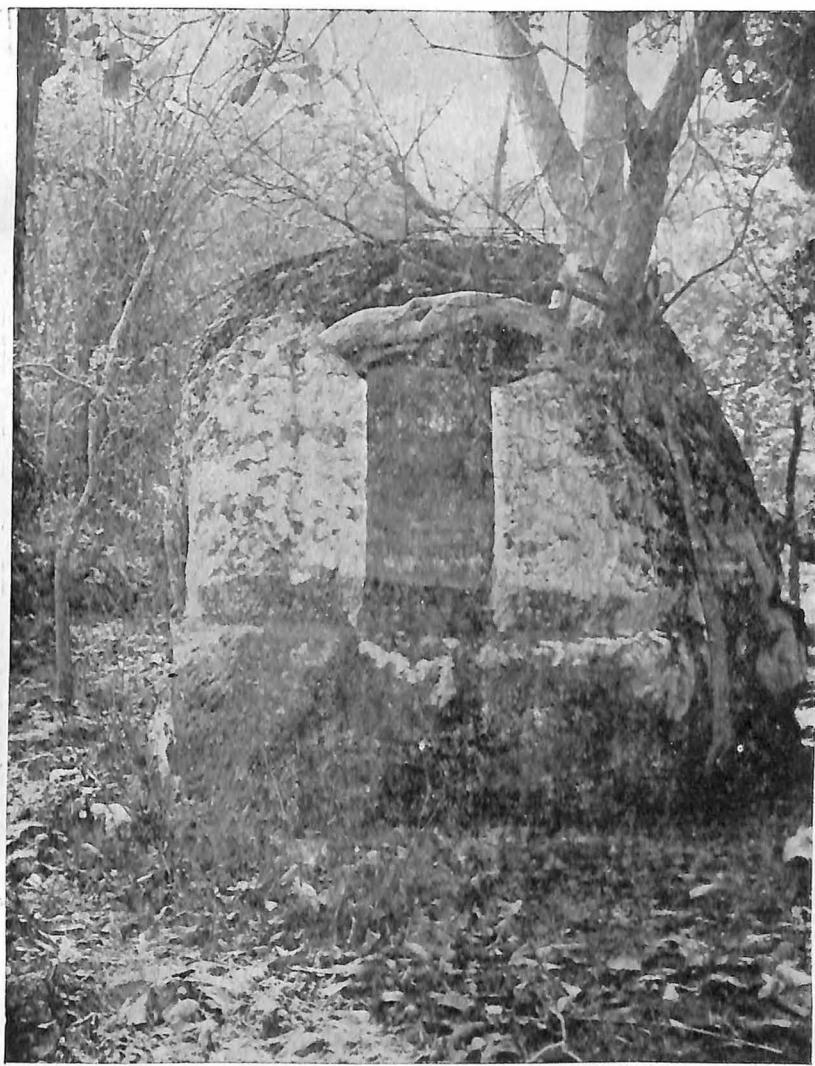
(a) DAGOBA NO. 1 AT KARKUNDA

Beginning from north ; first there is a big boulder about eight feet higher than the surrounding level and eight feet in diameter. This boulder had been carved into the shape of a Dagoba (Plate I) with a six-inch broad offset which runs all-round. On each cardinal side there is a niche in which the figure of the Buddha is to be seen in full relief seated on Padma Asana (Lotus throne) in a meditative mood. From the small patches of paint, it appears that in their pristine days the inside of these niches was painted. Somehow a tall tree has sprung up on the northern ridge of the Dagoba. The result as could be expected is disastrous. It has caused considerable damage to the northern niche and a big portion of the boulder which was just above the niche has fallen down and is lying close by. This injurious tree is to be carefully and immediately removed and its roots should be treated with chemicals that may check its future growth.

These relics of Buddhist culture in the Telugu speaking districts of H.E.H. the Nizam deserve careful conservation and preservation. The question may be discussed in detail when it is taken up. But at present it is necessary to mention that immediate steps should be taken to remove the rank vegetation from above and around the monuments and stop its future growth. Steps should also be taken for the proper drainage of rain water. It appeared to me that there is no proper outlet for the rain water which gets in the cells through the entrances. Water should not be allowed to accumulate on the top of these monuments and around their base.

The entrances to the cells should be fitted with perforated doors, so that the air inside may not become foul by getting stagnated. The entrances have got sockets which show that once they were fitted with doors. Barbed wire may be put around the Dagobas. This may help in saving the beautiful images of the Buddha from being subjected to vandalism. In the best interest of the monuments the appointment of a chowkidar is most desirable. To the south-east of the hill is a stream. The area between the hill and the stream is very interesting. Although it has been under cultivation since very long, yet even to this day we can pick up old potsherds, and brickbats in large quantities in this area. The presence of brickbats aroused my curiosity and upon inquiries it was disclosed that even large size bricks are also sometimes available in the field. As a matter of fact, I myself could see in the house of Mr. Gopal Rao, Deshmukh of Hemachandrapuram, some bricks which measured $1' \times 7'' \times 2\frac{1}{2}''$. It is quite likely that excavations between the hills and the stream and at some other suitable sites in the vicinity may yield valuable results.

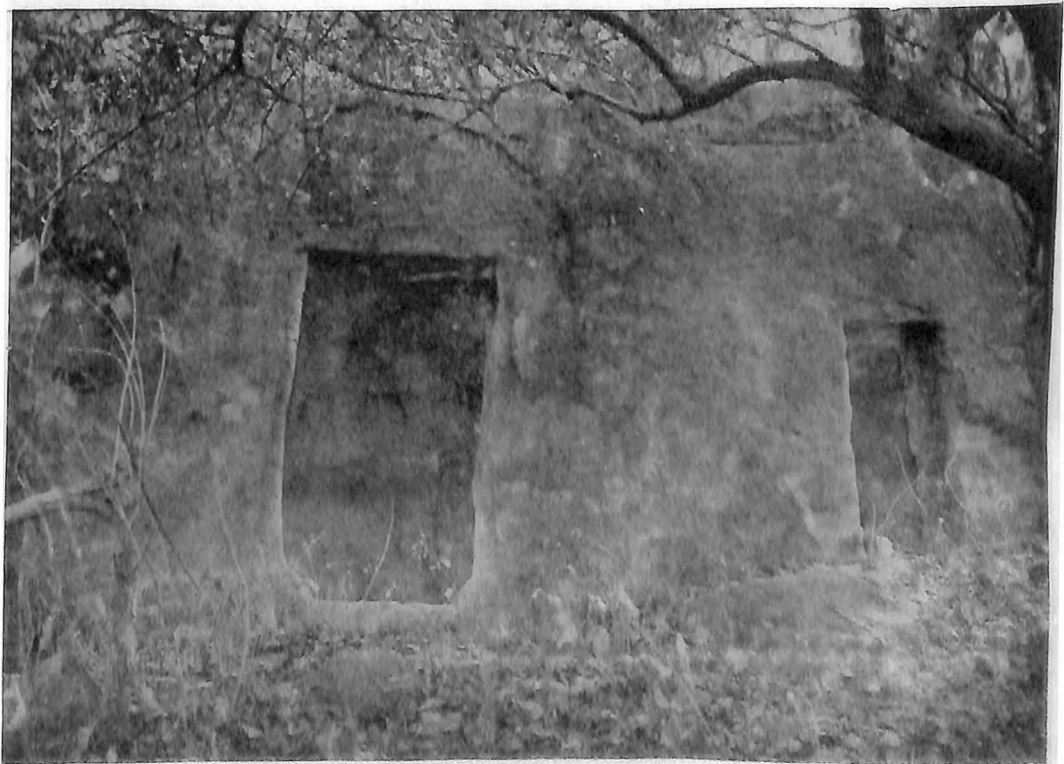
(b) THE CELLS AT KARKUNDA

At a distance of about one hundred feet from the Dagoba due south-east, there are two cells facing the west which have been cut out of a single piece of rock. The approach to these cells was overgrown with shrubs and bushes. It was after cutting them down that I could get admission into the cells, the northern cell is rectangular in plan and measures nine feet north-south and six feet east-west, the roof being about six and a half feet higher than the floor. The walls are sculptured although figures have been very much damaged. The eastern wall bears the figure of the Buddha with a Chauri-bearer on each side. The northern and southern sides of the wall bear the life size figures of Dwarpalas carved in the conventional form, claiming some artistic merit. But the ravages of time and the weathering of the rock has deprived them of their original charm.

Immediately to the south of the first cell is the other. In plan it is similar to the first but of smaller dimensions, measuring 6 feet north to south and five feet east to west, the height being only five and a half feet. The arrangement of the sculptures is also nearly the same as in the first cell.
