**THEORY AND PRACTICE OF
HERITAGE CONSERVATION AND RESTORATION
OF RASHTRAPATI NIWAS, SHIMLA**

CHHERING DORJE

INDIAN INSTITUTE OF ADVANCED STUDY
Rashtrapati Niwas, Shimla 171005

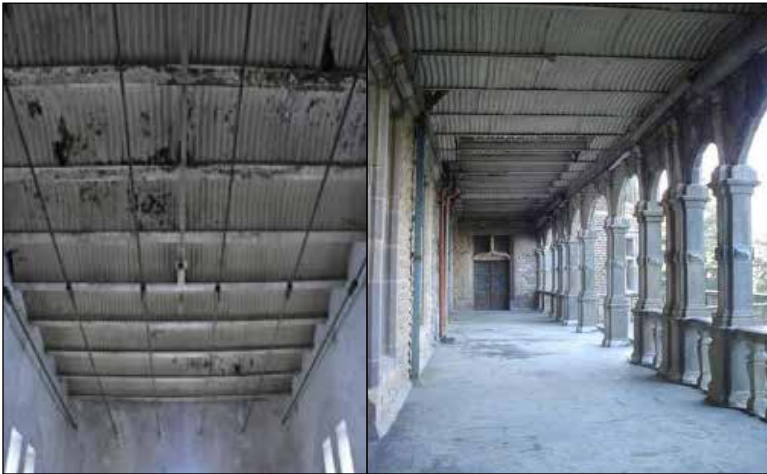
Jack arch roof deterioration due to corrosion, damp and seepage from top roof

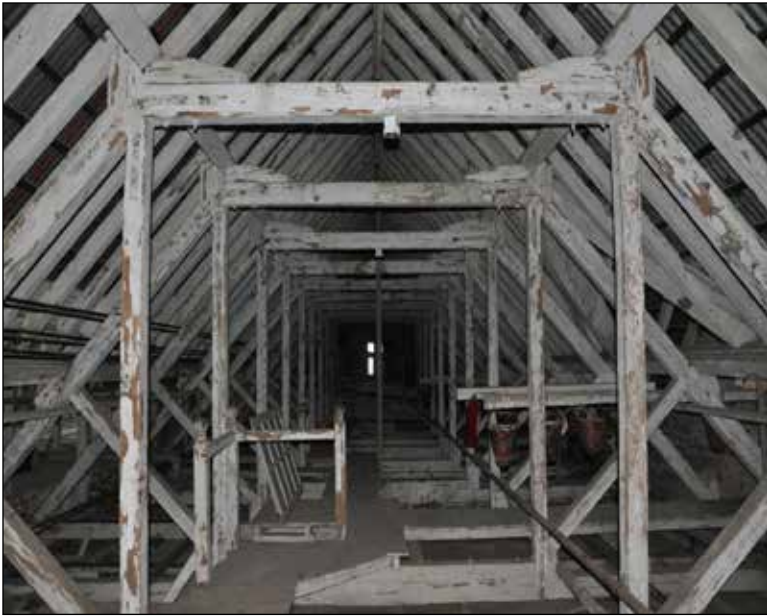
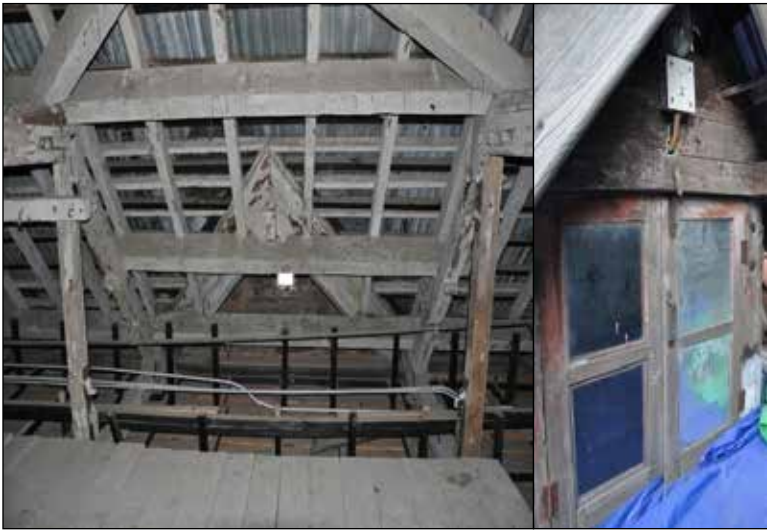
Interior view of the attic and dormer west facing

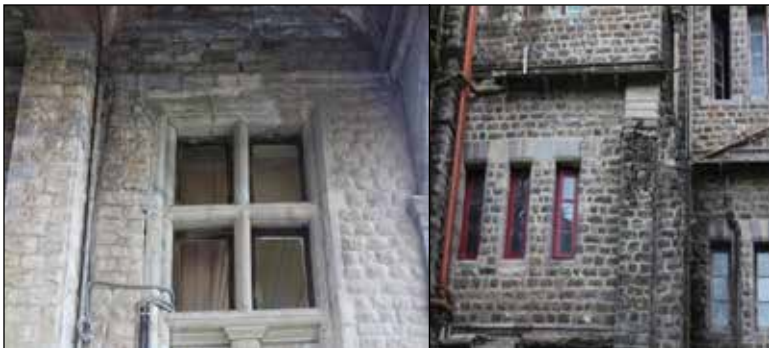
Main block showing masonry cracks at various locations

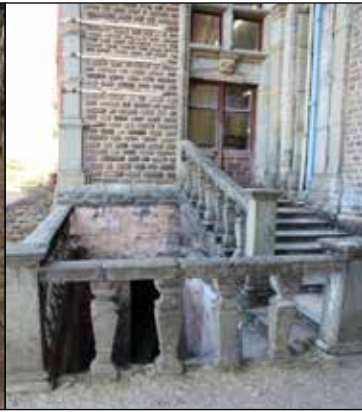
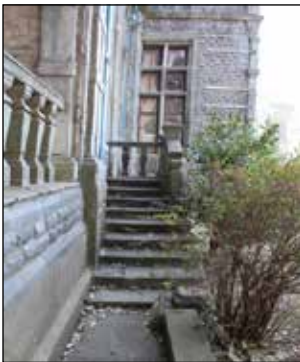
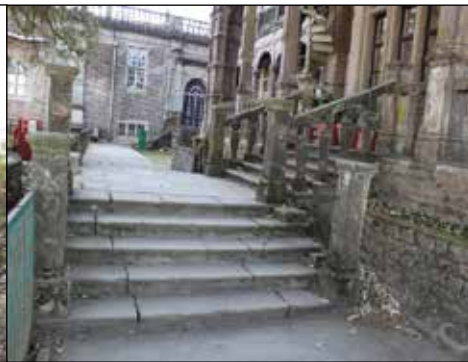
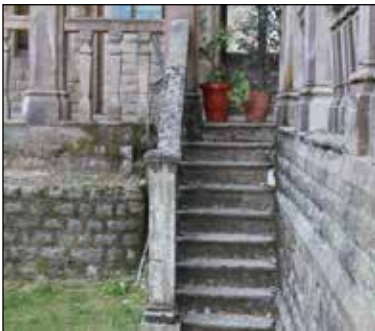
Present conditions of the stone masonry stairs

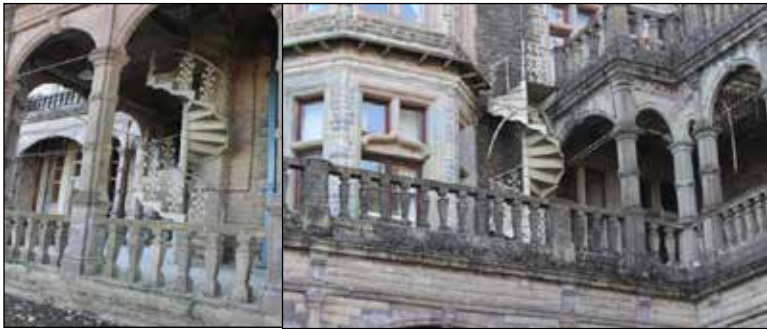
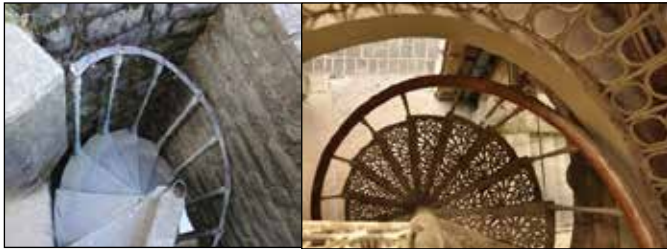
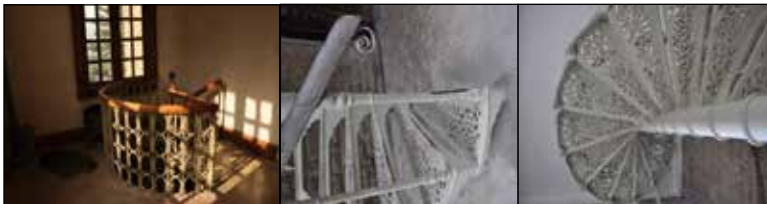
Conditions of the stone and cast iron spiral stairs at different locations

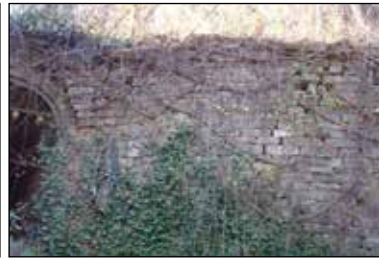
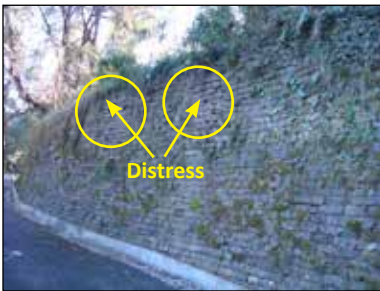
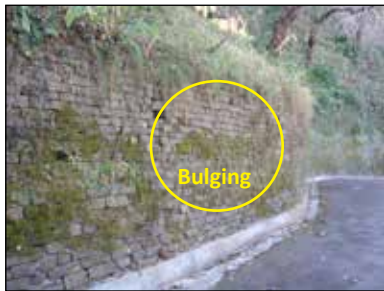
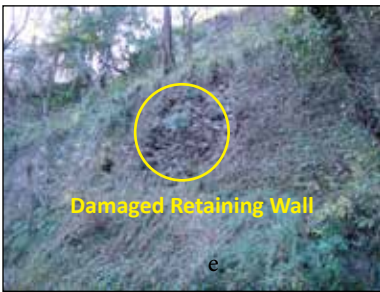
Damaged and distressed condition of rubble masonry retaining walls.
Source: IIAS.

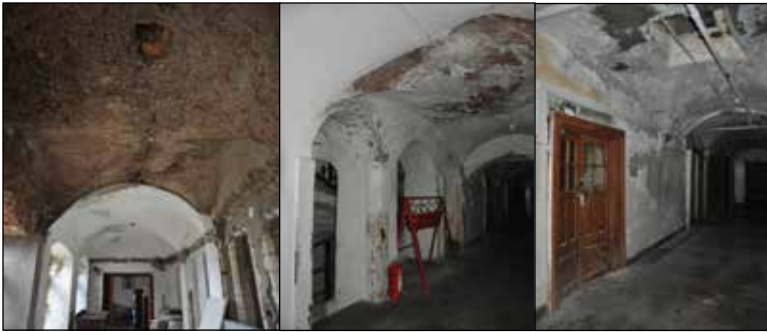
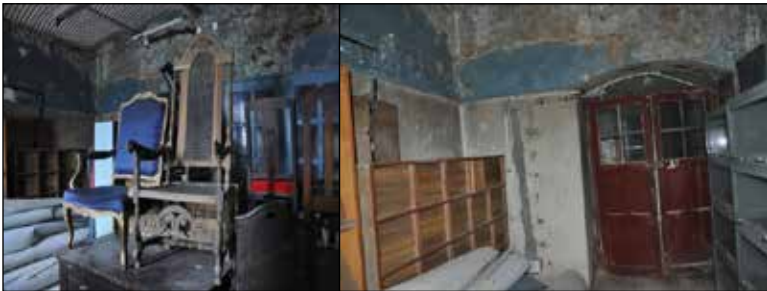
Deteriorated and distressed condition of the vaulted ceilings of corridors and rooms of Kitchen Wing

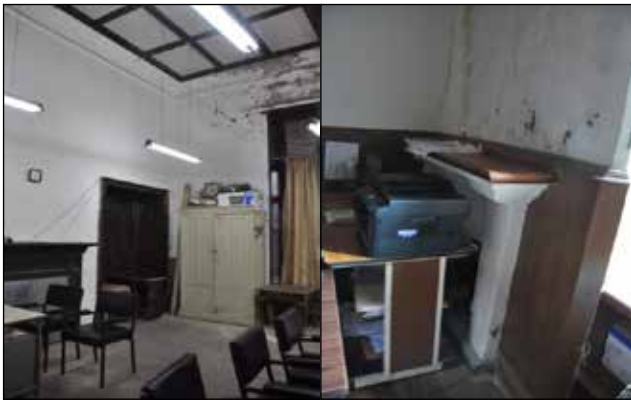
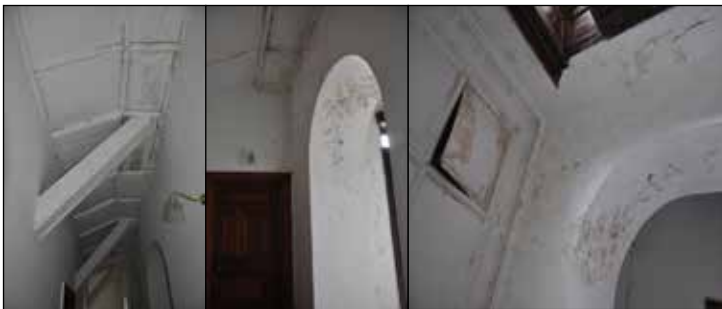
Ceiling and wall damages at various locations due to dampness and seepage from roof top

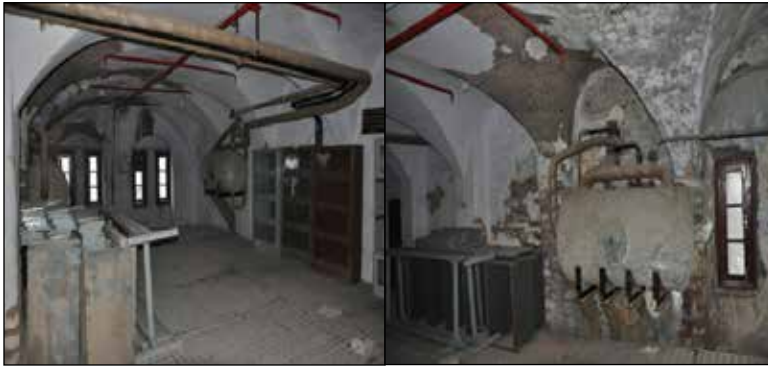
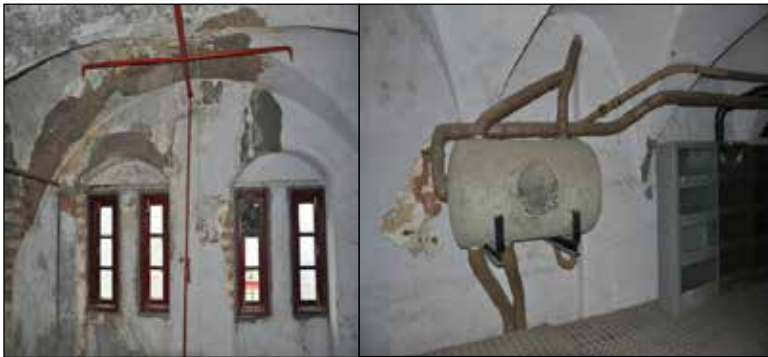
Kitchen Wing: deteriorated structural conditions of the rooms at laundry level

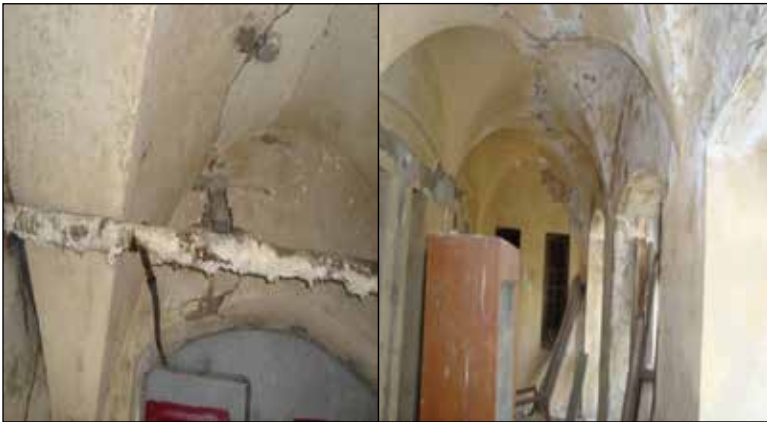
Kitchen Wing: Deteriorated vaulted chambers of the Kitchen due to cracks in the ceiling and damp.

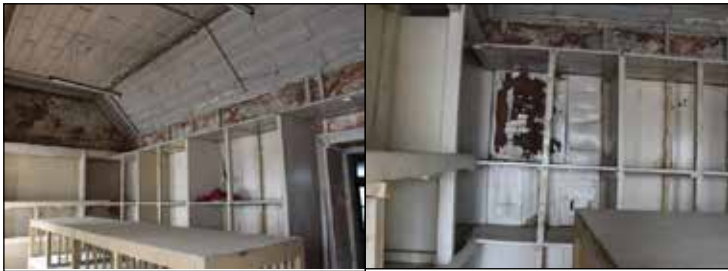
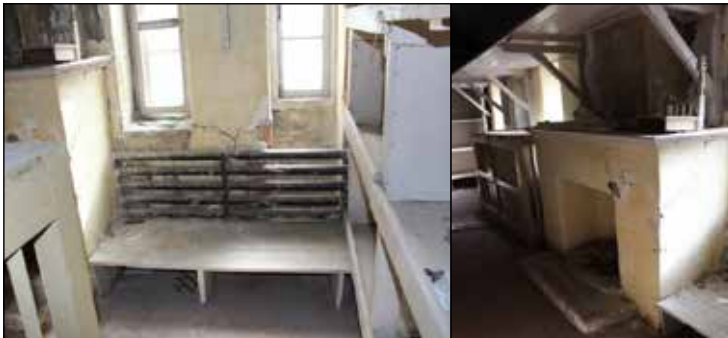
Deteriorated structural conditions of the top floor corridor and linen room of Kitchen Wing.

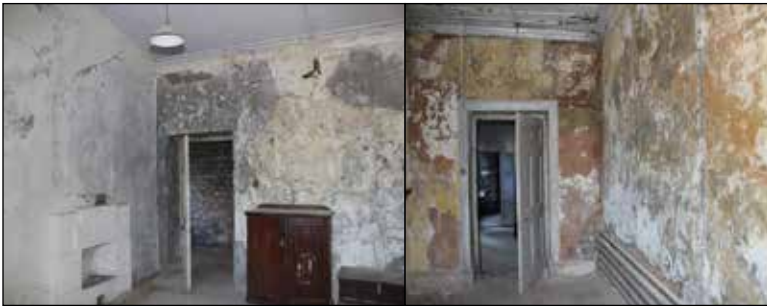
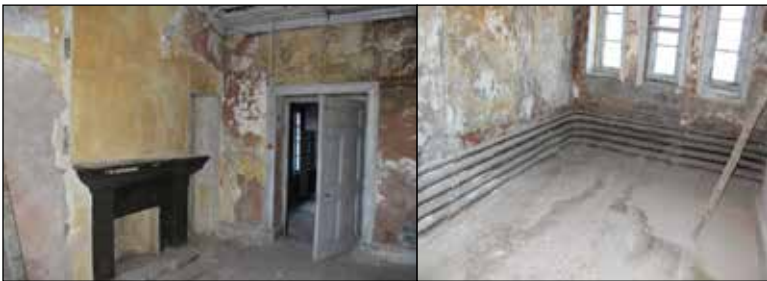
Kitchen Wing: deteriorated structural conditions of the top floor corridor and side rooms.

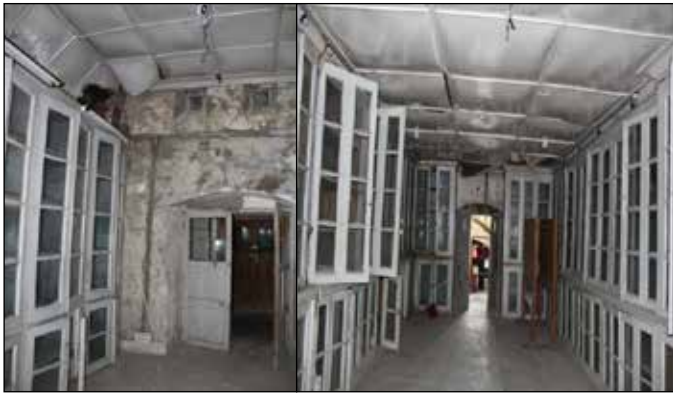
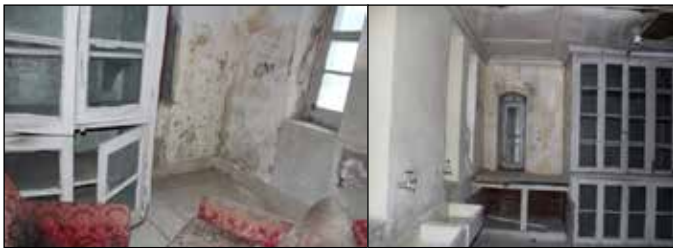
Kitchen Wing: deteriorated structural conditions of the top floor side rooms.

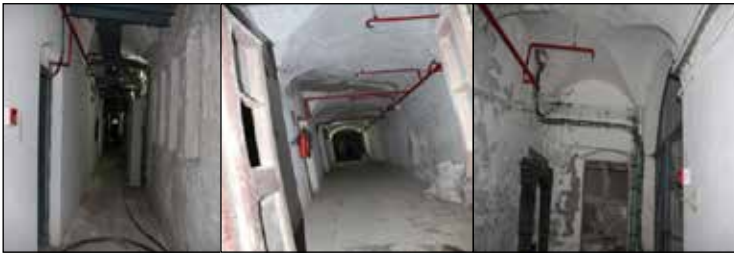
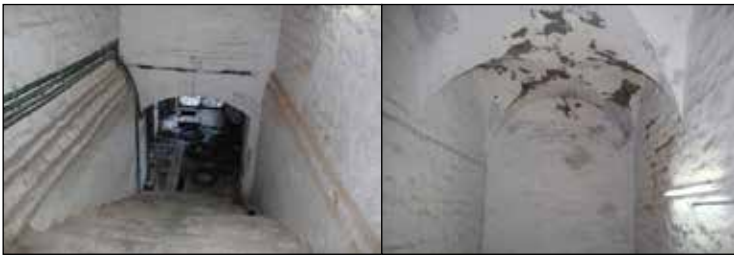
Kitchen Wing: deteriorated structural conditions of the corridor sub-basement and north main entrance.

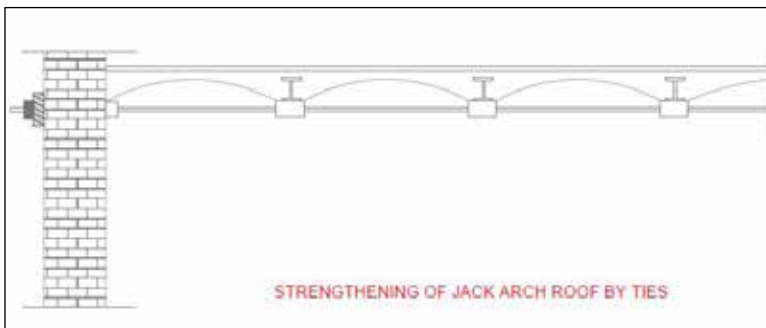
20. Treatment of Jack arched roofs: Jack arch roofs are provided in some part of roofs especially in outer corridors in the building. The steel joists and CGI sheet arch supporting the jack arch slab at first and second floor level on the north-west and north east portion of the main building are corroded at certain places. The visible extensive corrosion is in the verandas with jack arch type roofing having CGI sheets in arch shape placed over I-sections. Affected sections are to be treated with rusticides and passivators to arrest further corrosion.

The corroded and rusted steel sections are strengthened by welding additional flange at the bottom and if both flange and web are corroded the whole joist is to be replaced or provided with

additional joists adjacent or below the member in the case of the Jack arch. The rods shall be provided between the springing of the arches. This will relieve the walls from the thrust of the arches and the load transferred to the walls will be vertical. The top of the Jack arch having lime concrete shall first be grouted using lime cement grout. Finally, the steel members shall be treated with a coat of primer followed by epoxy paint.
